Fractographic analysis of failures

Moeser, M.; Schmidt, V.

Proc. 7th Congr. Materials Testing, Budapest 1978, Vol. II, p. 851-855

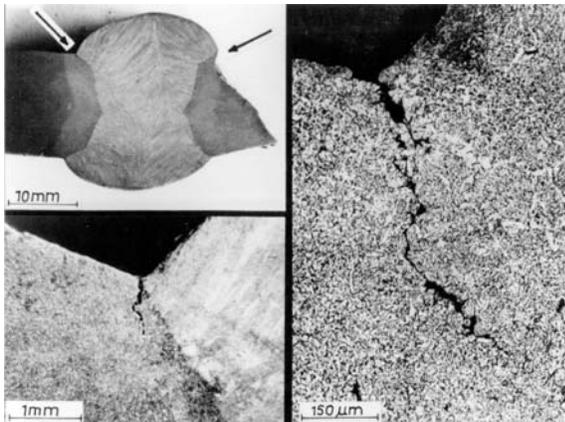
A few days after starting-up, a superheated steam pipe burst along the longitudinal welding seam. The fracture originated at cracks in the heat-affected zone near the weld fusion line (coarse grain zone). On the other side of the weld seam cracks could also be detected (Fig. 1). The surface was partly hot tinted but in some areas we could see by means of the SEM (scanning electron microscope) that the structure was intergranular with very fine dimples on the grain boundaries (Fig. 2).

Fig. 1: Intergranular crack near the fusion line; strong reinforcement of the weld

The position and surface of these cracks are typical of stress relief cracks (reheat cracks). Such cracks normally originate during post-weld heat treatment. It is supposed that during welding a solution of carbides occurs in the austenite grains followed by reprecipitation during relief treatment [1, 2]. The primary austenite grains are hardened, and creep during stress relief is confined to a narrow soft, precipitation-free zone along the grain boundaries. Cavities are nucleated and link to a crack network.

It is known that stress relief cracks are associated with stress raisers, such as changes in the cross-sections of pipes. In our case the strong reinforcement of the weld acted as a stress raiser. Moreover it was proved that stress relief treatment had not been performed. Therefore stress relief and crack nucleation can be considered to have occurred during the first days of high-temperature service, until bursting.

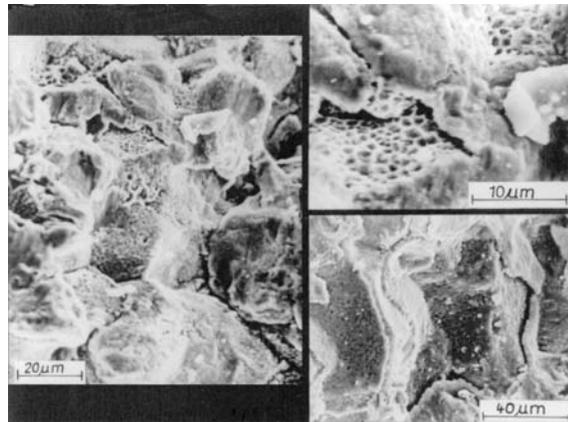
Fig. 2: The opened intergranular crack with very fine dimples on the grain boundaries (right above)

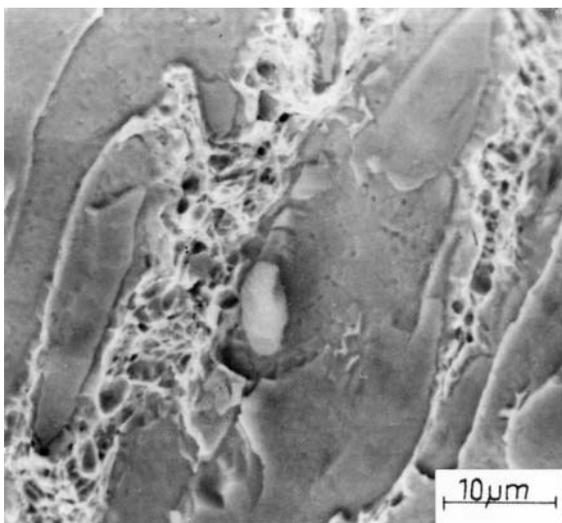
The cracks were opened for further investigations. In the parent plate accumulations of flat inclusions could be observed in the SEM (Fig. 3). The inclusions were determined by EDAX (energy dispersive microanalysis) to be mainly sulphides (Fe, MnS). In the region of the fusion line the sulphide inclusions had been completely or partly molten. The sulphide melt had formed fern-like structures on the austenite grain boundaries (Fig. 4). Such „sulphide splashing” and the crack nucleation only occur under the action of stresses (shrinking stresses) [3].

Fig. 3: Sulphide inclusions in the parent plate

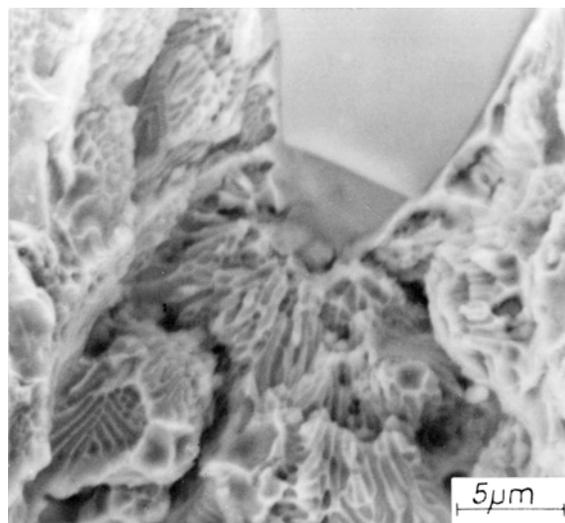
Fig. 4: Partially molten sulphide inclusion with fern-like structures in the region of the fusion line

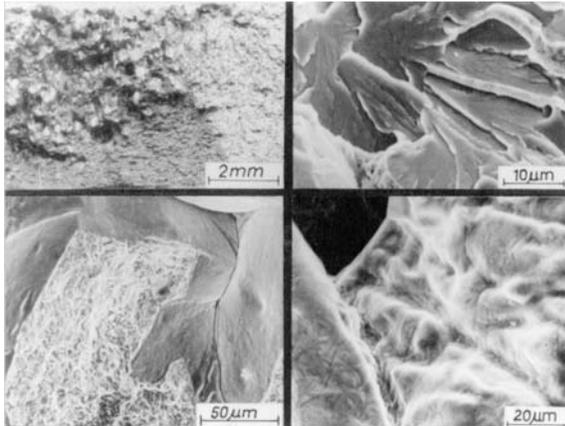
Porosity and cracks were detected in forged steel parts. In the most strongly forged zone, the fracture surface appeared to be very coarse grained already for the naked eye (Fig. 5). In the less forged region the surface was glittering and here cleavage fracture could be viewed with the SEM. In the coarse-grained area the fracture was intergranular with strongly oxidized grain boundaries, which had been partly molten

(dendritic structure) thus being the cause of cavities. In some areas the shells on the grain boundaries peeled off.

Fig. 5: Headed steel part: coarse grains in the strongly forged region; grain boundaries with dendritic structure

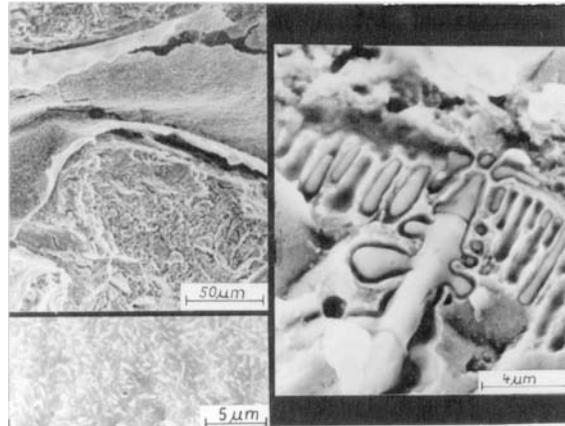
Furthermore fern-like structures of sulphides (Fe, MnS) could be detected on the grain boundaries (Fig. 6).

Fig. 6: Peeled off oxide shells (left) and fern-like structure of low melting sulphides (right)

It is assumed that in the case of strong overheating sulphur segregates to the grain boundaries and fluid sulphide films are produced there [4]. Sulphide splashing then occurs during forging.

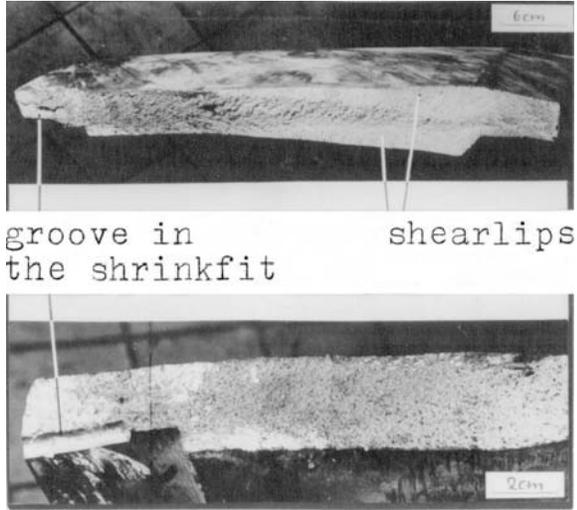
The end ring of an air cooled generator failed during service. The end ring was produced from austenitic manganese chromium steel and supported at two positions on the rotor shaft. Extensive shear lips could be seen on the fracture surface (Fig. 7), with the exception of the first third. Shear lips characterize a ductile fast fracture. Thus the first third of the fracture surface must be considered to be the zone of slow crack propagation.

Fig. 7: Macrograph of fracture surface of the end ring

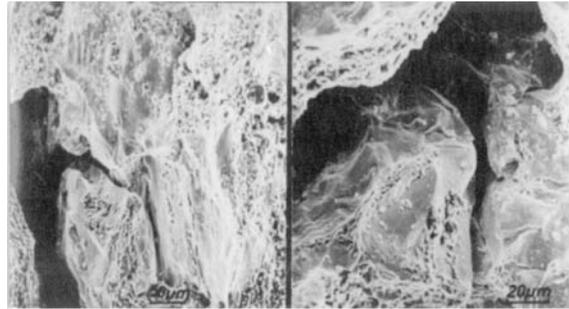
Viewing this area with the SEM we found complete intergranular fracture with secondary cracks (Fig. 8).

Fig. 8: Intergranular fracture in the slow-fracture zone

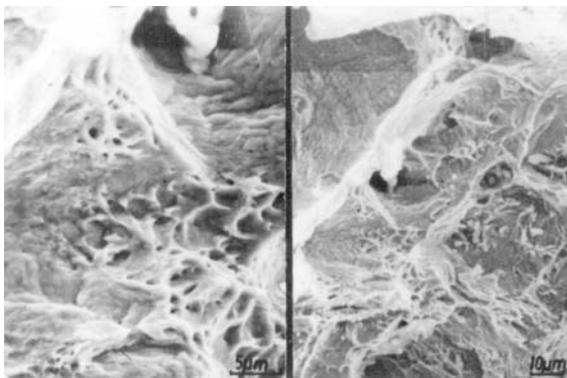
Fig. 9: Dimples and tearing in the fast-fracture zone

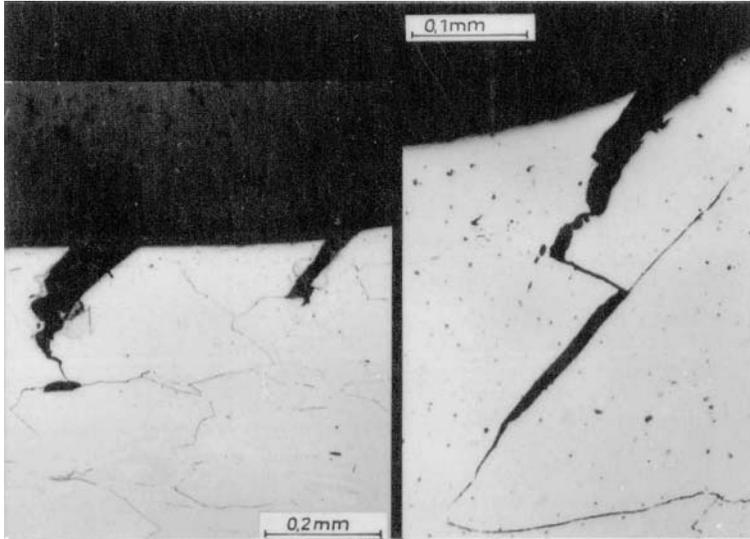
Fig. 11: Cracks (here under the groove) go transgranular to the first grain boundary, then they are intergranular [5].

It is known that in nitrate solution austenitic manganese steels have a great susceptibility to intergranular stress corrosion cracking [6, 7], and even in distilled water if the steel is in the sensitized state [8]. Therefore we assume as in [6, 7] that the failure is due to stress corrosion cracking. It is supposed, that the stress corrosion was caused by humidity from (industrial) atmosphere possibly acting together with nitrates from corona discharge [6, 7].

- Cracks were present caused by fretting.
- Strong workhardness was existing around the grooves induced by their manufacturing.
